# Manhole Inspection Summary

Manhole # S29M\_\_031MH

Insp Date: **12/4/08 2:07 PM**

**Location** Address: **Sterett St.**

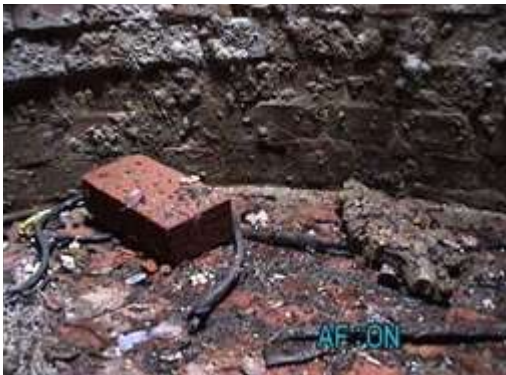
Misc

debris on the bench

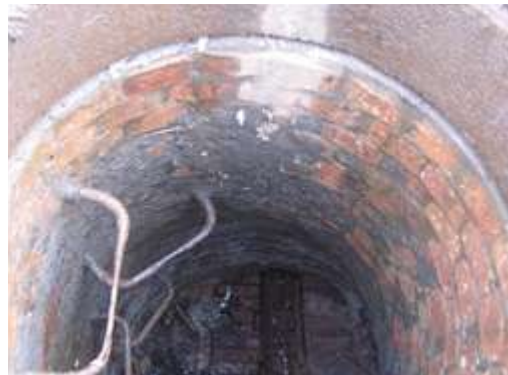
Defect 3

Infiltration: ☐ None ☐ Joint ☐ Cracks ☐ Mortar ☐ Roots ☒ **Wall**

chimney and corbel infiltration from wall

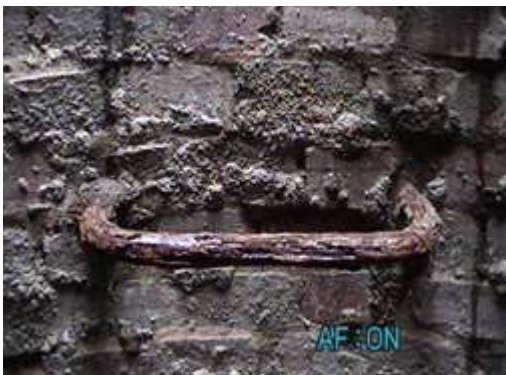
Defect 2

**Steps** Count: **5** Missing: **0** ☒ **Corroded**

corroded step

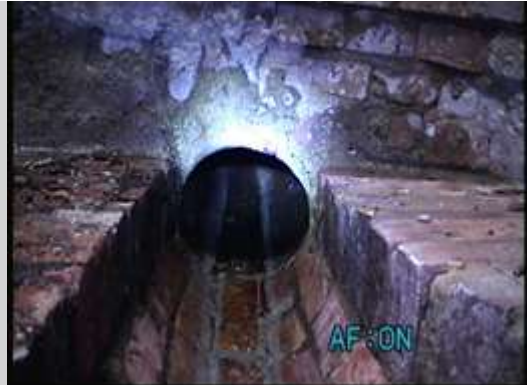
12 O'Clock Outflow

8 in. Circular Gravity Sewer  
Pipe Out @ 12 O'Clock

Pipe Height: **8.4** (in.) Rod and Bar (Angled)  
Pipe Material: **Clay** ☐ Pipe Lined  
Invert Depth: **8.62** (ft.) Flow Characteristics: **None**  
Deposits: ☒ None ☐ Mud ☐ Sludge ☐ Debris ☐ Grease  
Silt Depth: **0** (in.) Deposits Extent:  
Infiltration: **None** Pipe Seal Cond: **Sound**

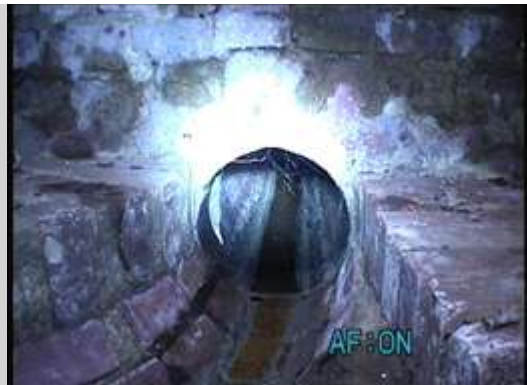
3 O'Clock Inflow

8 in. Circular Gravity Sewer  
Pipe In @ 3 O'Clock

Pipe Height: **8.4** (in.) Rod and Bar (Angled)  
Pipe Material: **Clay** ☐ Pipe Lined  
Invert Depth: **8.52** (ft.) Flow Characteristics: **None**  
Deposits: ☒ None ☐ Mud ☐ Sludge ☐ Debris ☐ Grease  
Silt Depth: **0** (in.) Deposits Extent:  
Infiltration: **None** Pipe Seal Cond: **Sound**
